Test Report No. SHAEC1826470801 Date: 30 Nov 2018 Page 1 of 4

The following sample(s) was/were submitted and identified on behalf of the clients as : Carbon Film Fixed

Resistors

<u>Halogen</u>

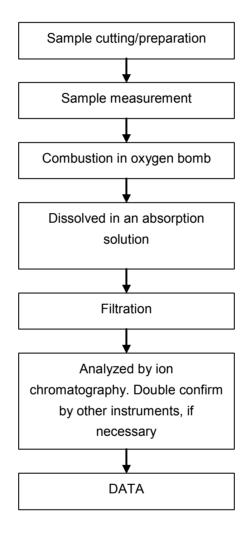
Halogen Testing (oxygen bomb) Flow Chart

Test Method: With reference to EN 14582: 2016, analysis was performed by IC.

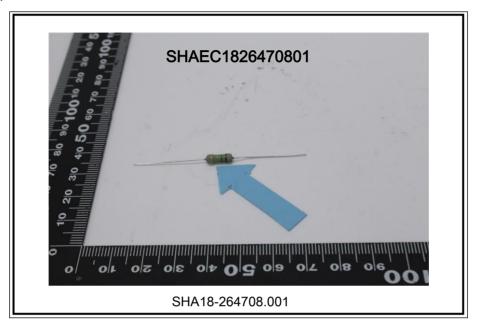
Sample photo:

Specimen No. SGS Sample ID Description SN1 SHA18-264708.001 Colorful body part
